AQUATIC FACILITY EVALUATION

Tony Aguirre Community Center

Indoor Swimming Pool

(Inspection Date: November 12, 2010)

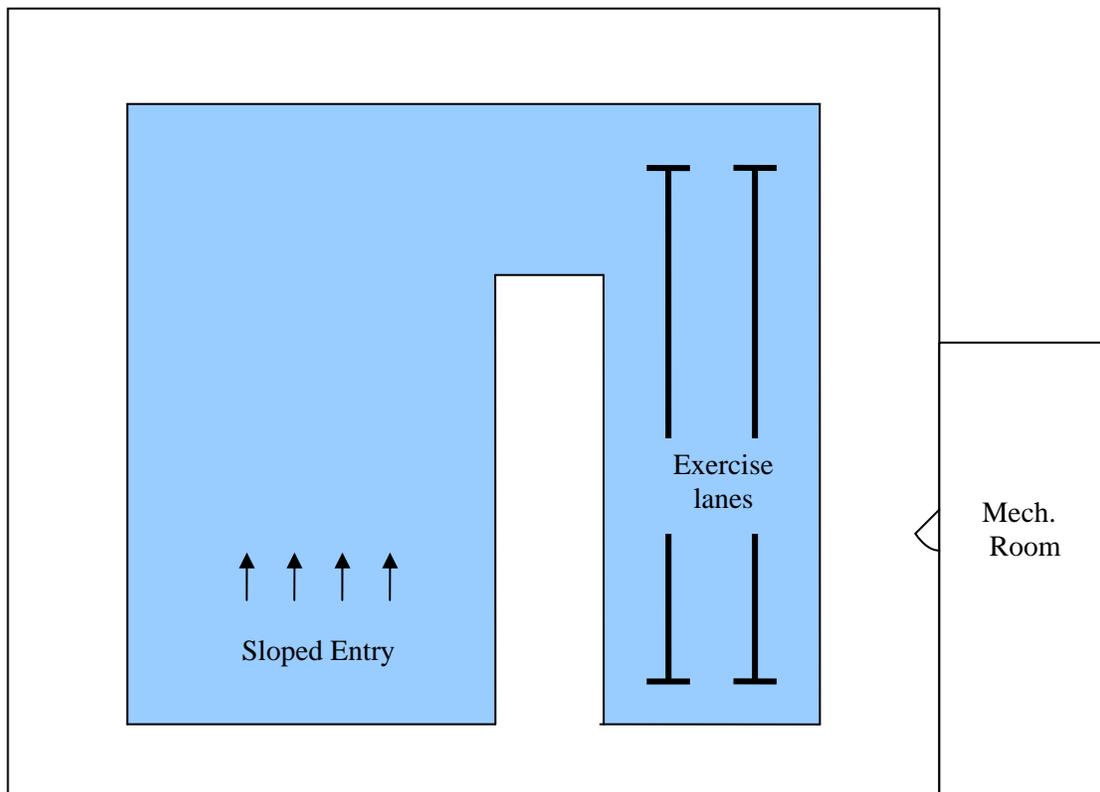
Fig 1. Pool configuration

The current configuration of Tony Aguirre Community Center pool is “U” shaped. The length of the pool is approximately 82 feet (25 meters). The width of the exercise/racing lanes area is approximately 15 feet. The width of the sloped entry area is approximately 26 feet.

The pool water depth varies from zero inches to approximately 5 feet-6 inches. The deepest end of the pool has two (2) anchoring embedment for racing/starting platforms.

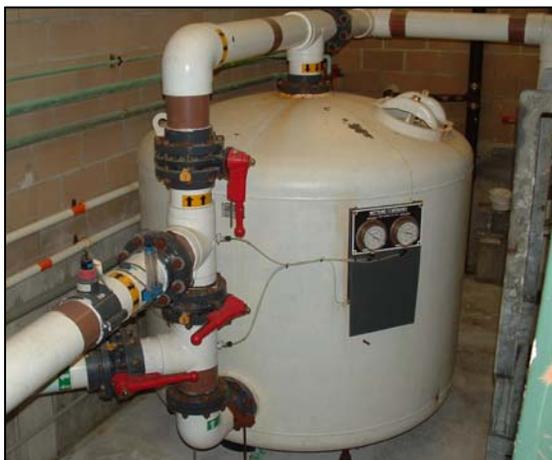
Fig 2. Filter

During the inspection of the basin sand (likely filter media) was present in the gutter trough adjacent to the pool office. The amount of sand/media was minimal; however, it requires attention. The presence of sand/media in the trough is an indication that there may be internal damage in the filter. The facility staff should begin planning to repair the internal components of the filter that are allowing the discharge of media.

1. Service the pump per the manufacturer's recommended schedule
2. Inspect and repair the damaged internal components of the filter.

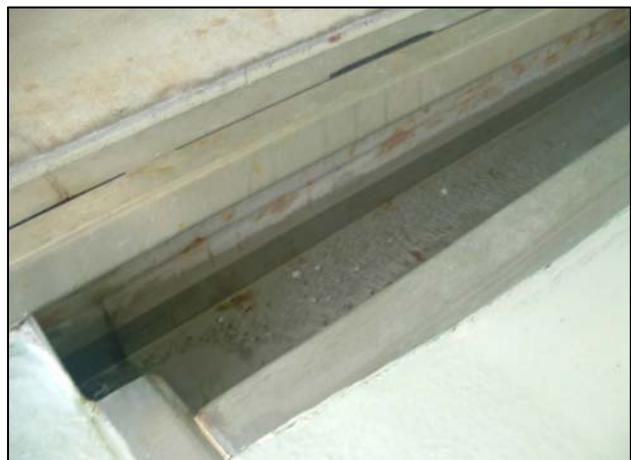
Fig 3. Sand/media in gutter trough

- VGB Grating
- Starting platforms are in 5'-0" deep water
 - o 2 sets of anchors in the deck
- All zero-depth entry sprays freely flowing
- Sand/filter media present in gutter trough, near natatorium entrance

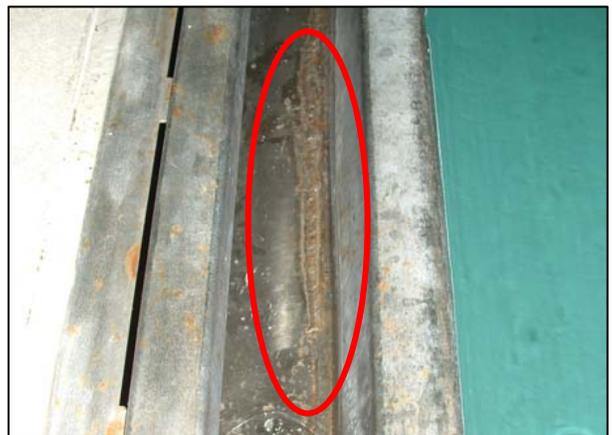
Fig 4. Leaking seam

The gutter system appears to be operating in satisfactory condition, however, there is an area that requires attention. Near the mechanical room, a seam in the pressure chamber is leaking. The filtered water in the pressure chamber is leaking into the return trough that drains to the surge tank.

After a closer review, there appears to have been an attempt to seal the leaking seam. The area has excess welding material and marks that do not appear in other areas of the trough, and do not seem to be consistent with the manufacturing welds done in the during production factory. There is a possibility that the attempted repair has compromised the watertight return trough. The repair welding may have penetrated through the bottom of the gutter system. This may be allowing water to leak out the bottom of the pressure chamber and/or out the bottom of the return trough. If this is the case the water would be leaking into the grout bed that is under the gutter system.

Water leaking into the grout bed is a concern. Over time the water could erode the bed. This will adversely effect the structural integrity of the gutter system, and potentially the basin. Also, if there is enough erosion the water could create a path and follow outside of the basin, into the sub-grade materials behind the shell.

- Pressure side of gutter trough exhibited a leak
 - o Location: 5'-0" deep section, adjacent mechanical room
 - o Seam of pressure column appeared to be have deteriorated

- o Seam appeared to have be repaired previously
- Depth markers on vertical portion of the gutter face are peeling
- Gap in deck sealant between deck slab and gutter

The extent of the leaking from the gutter system is unknown, however the leak needs to be repaired in the pressure chamber in the near future. It is recommended that the seam be sealed and return trough patched.

1. Repair leak in gutter pressure chamber – have welding professional inspect previous repair for indication of damage (burn-through)of the gutter
2. Patch return trough
3. Clean corrosion from gutter
4. Repair deteriorating sealant
5. Repair or water depth markers

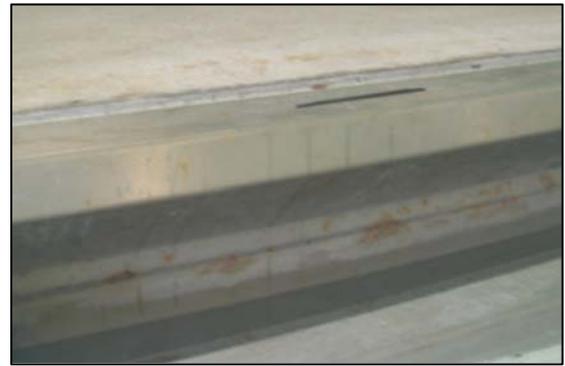
Fig 5. Corrosion in trough

During the inspection, rust was present in the gutter system, specifically in the zero-depth area. It is important to closely monitor these areas. The corrosion can be removed with minimal effort and minimal harm to the structure.

- Corrosion on gutter trough
- Handrail by locker room entrance is loose
 - o Remaining handrail appeared to be secure under a moderate hand force
- Minimal deck crack present in the peninsula

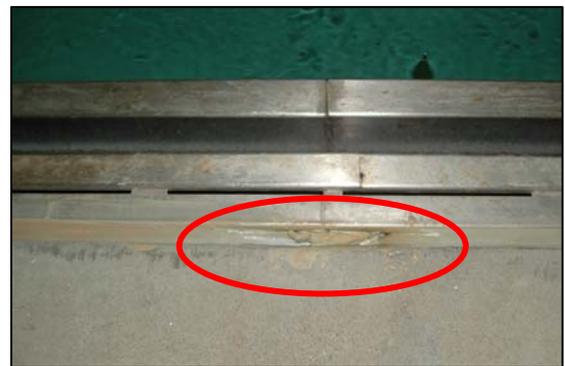
Fig 6. Gap in sealant

During the initial construction a sealant was placed between the back of the gutter and the concrete deck. This sealant is placed to prevent water on the deck from getting behind the gutter and under deck. At the time of the inspection there were locations where the deck sealant shows signs of deterioration, damage, and even removal. It is important to have these areas repaired. If the conditions remain, water may penetrate the sub-grade materials, over time erosion can occur. Such erosion can create voids under the concrete deck and around the pool shell, reducing the structural integrity of these structures. All the damaged, deteriorating or missing sealant should be removed. The joint should then be properly cleaned and prepared for the application of new sealant.

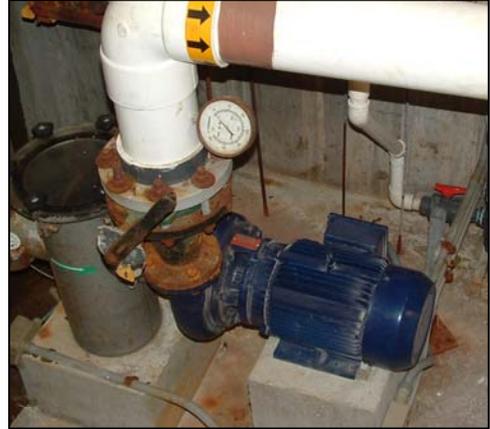
Fig 7. Recirculation pump

The recirculation pump is the component that is responsible for creating the turnover rate. During the inspection, Larkin observed that the recirculation pump is sized to operate at 402 GPM. This operating condition exceeds the minimum regulations. However, the facility should still verify the pump is operating in this designed range.

- o Heater space is naturally ventilated – 24” x 24” louver to outside
- Pump
 - o Nameplate Conditions: 402 gpm @ 65’
 - o Aurora 3x4x9B, Type: 341BE
 - o Motor: 10 HP, 230/460, 3Ø, 1740 RPM, TEFC

1. Confirm turnover rate meets 6 hour time period

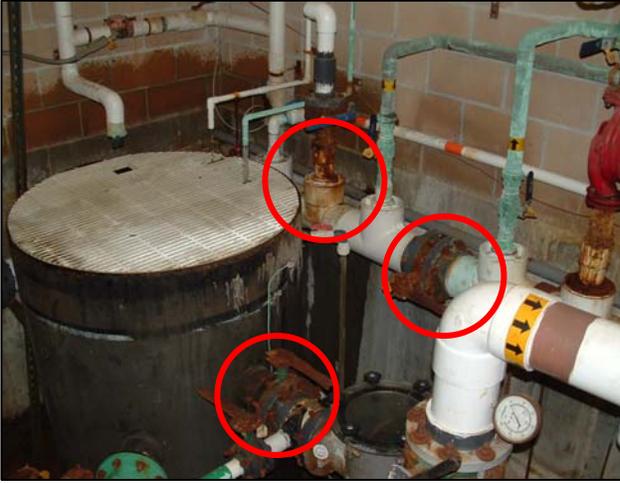
Fig 8. Mechanical room

During the site evaluation it was noticed that corrosion has built on components within the mechanical room. The majority of the corrosion has accumulated on pipe fittings. The corrosion has most likely developed from the combination of poor air circulation and the storage of the pool chemicals within the space. To help prevent further deterioration the chemicals should be stored in another location.

- Corrosion present on the electrical panels
- Corrosion on recirculation valves and valve handles
- Chemical stored were being stored in the equipment space – 2 buckets

1. Remove pool chemicals from equipment area
2. Monitor corrosion, replace equipment as needed

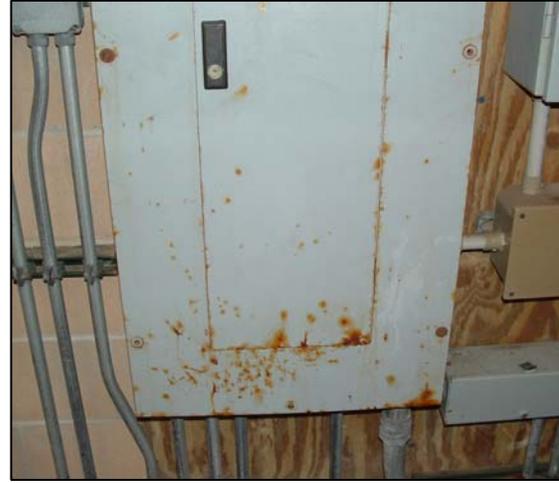
Fig 9. Electrical panel

In addition to the concern of the piping and equipment corrosion, the area's electrical panels showed signs of corrosion. Facility staff should monitor the condition so that the situation does not worsen, causing operational malfunctions and compromise the safety of staff.

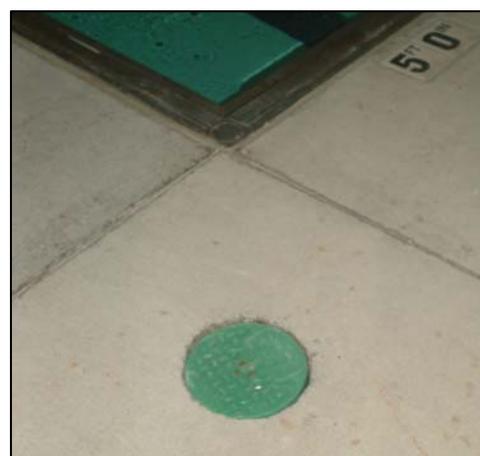
Fig 10. Valve cover

There is a valve located within the deck, adjacent to the mechanical room entrance. The valve has a high-density plastic cover. At the time of the inspection the cover was not secured in place. The staff should secure this valve cover to prevent a tripping hazard, and prevent potential tampering.

- o Location: across from mechanical room door
- Valve cover not fastened to deck
 - o Location: corner of deck near 5'-0" deep water
- No outlet cover on electrical receptacle

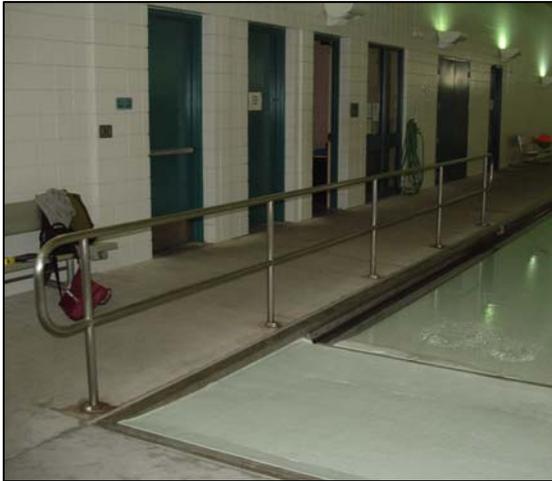
Fig 11. Loose handrail

There are stainless steel handrails on the deck that run parallel to the sloped entry area. The handrails appear to be in acceptable condition. However, the rail across from the natatorium entrance, and pool office, wobbles under a moderate hand force. The staff should securely fasten the handrail for patron safety.

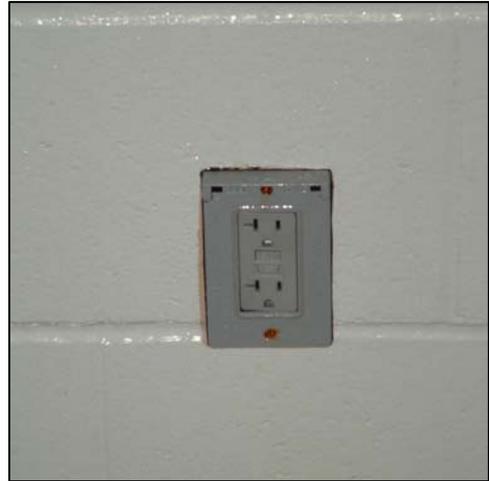
Fig 12. Receptacle cover

The perimeter wall of the natatorium has numerous electrical receptacles. A few of the receptacle have loosened or missing cover plates. The staff should repair or replace these covers to prevent potential hazards.
