AQUATIC FACILITY EVALUATION

Tony Aguirre Community Center

Indoor Swimming Pool

LARKIN AQUATICS

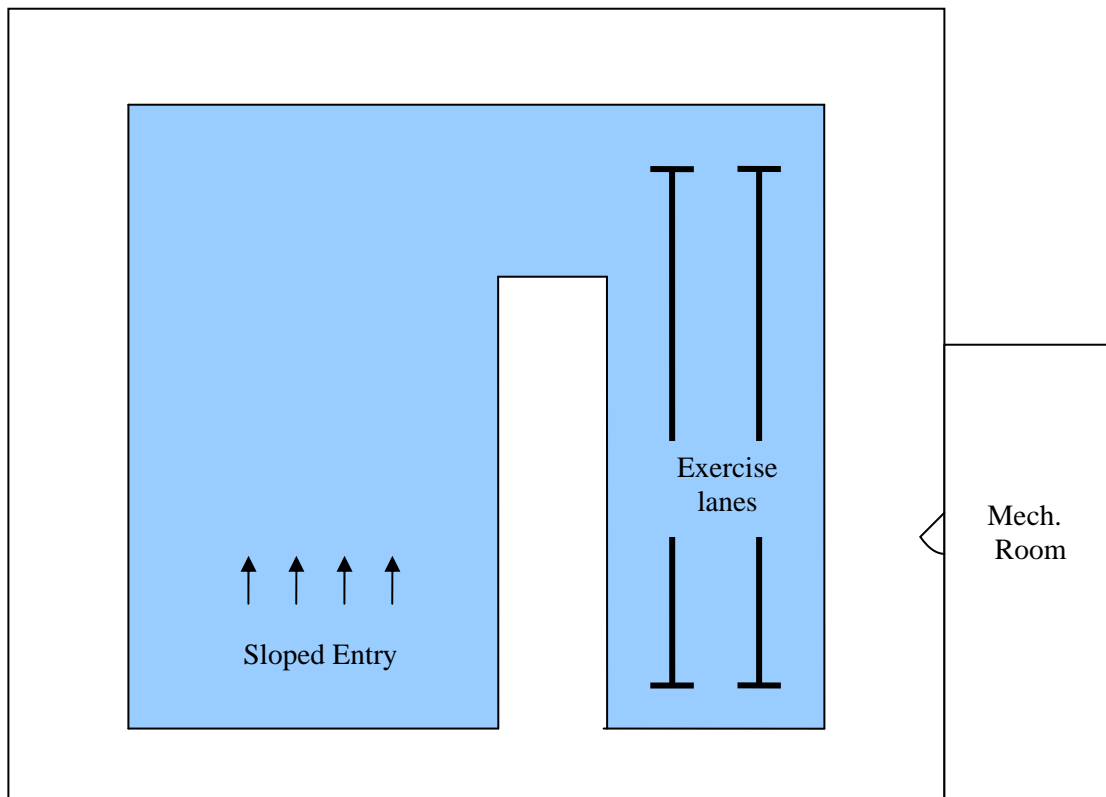
The current configuration of Tony Aguirre Community Center pool is “U” shaped. The length of the pool is approximately 82 feet (25 meters). The width of the exercise/racing lanes area is approximately 15 feet. The width of the sloped entry area is approximately 26 feet.

Fig 1. Pool configuration

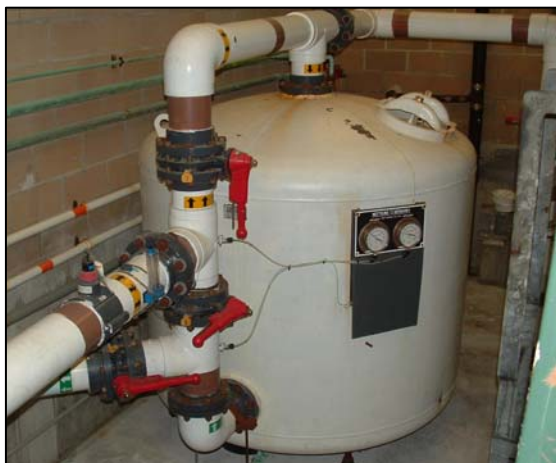
During the inspection of the basin sand (likely filter media) was present in the gutter trough adjacent to the pool office. The amount of sand/media was minimal; however, it requires attention. The presence of sand/media in the trough is an indication that there may be internal damage in the filter. The facility staff should begin planning to repair the internal components of the filter that are allowing the discharge of media.

Fig 2. Filter

- Filter – Neptune Benson
 - o 6’-0” Diameter
 - o Operating Influent: 17 psi, Operating Effluent: 13 psi (At the time of inspection)
- Chemical pump
 - o Operating conditions not legible

1. Service the pump per the manufacturer's recommended schedule
2. Inspect and repair the damaged internal components of the filter.

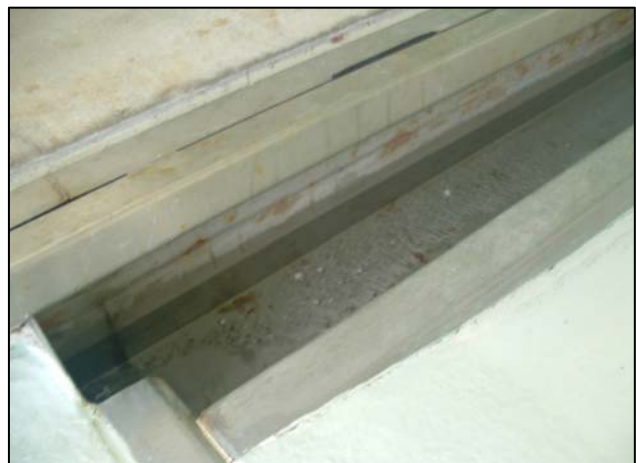
Fig 3. Sand/media in gutter trough

- VGB Grating
- Starting platforms are in 5'-0" deep water
 - o 2 sets of anchors in the deck
- All zero-depth entry sprays freely flowing
- Sand/filter media present in gutter trough, near natatorium entrance

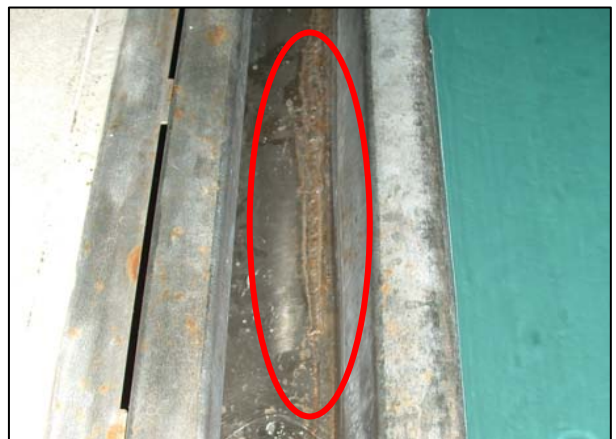
The gutter system appears to be operating in satisfactory condition, however, there is an area that requires attention. Near the mechanical room, a seam in the pressure chamber is leaking. The filtered water in the pressure chamber is leaking into the return trough that drains to the surge tank.

Fig 4. Leaking seam

After a closer review, there appears to have been an attempt to seal the leaking seam. The area has excess welding material and marks that do not appear in other areas of the trough, and do not seem to be consistent with the manufacturing welds done in the during production factory. There is a possibility that the attempted repair has compromised the watertight return trough. The repair welding may have penetrated through the bottom of the gutter system. This may be allowing water to leak out the bottom of the pressure chamber and/or out the bottom of the return trough. If this is the case the water would be leaking into the grout bed that is under the gutter system.

Water leaking into the grout bed is a concern. Over time the water could erode the bed. This will adversely effect the structural integrity of the gutter system, and potentially the basin. Also, if there is enough erosion the water could create a path and follow outside of the basin, into the sub-grade materials behind the shell.

- Pressure side of gutter trough exhibited a leak
 - o Location: 5'-0" deep section, adjacent mechanical room
 - o Seam of pressure column appeared to be have deteriorated

- o Seam appeared to have be repaired previously
- Depth markers on vertical portion of the gutter face are peeling
- Gap in deck sealant between deck slab and gutter

The extent of the leaking from the gutter system is unknown, however the leak needs to be repaired in the pressure chamber in the near future. It is recommended that the seam be sealed and return trough patched.

1. Repair leak in gutter pressure chamber – have welding professional inspect previous repair for indication of damage (burn-through)of the gutter
2. Patch return trough
3. Clean corrosion from gutter
4. Repair deteriorating sealant
5. Repair or water depth markers

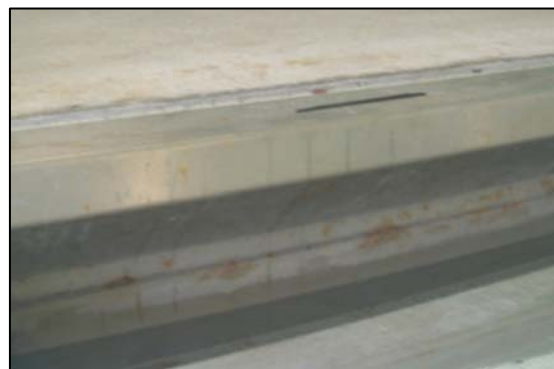
During the inspection, rust was present in the gutter system, specifically in the zero-depth area. It is important to closely monitor these areas. The corrosion can be removed with minimal effort and minimal harm to the structure.

Fig 5. Corrosion in trough

- Corrosion on gutter trough
- Handrail by locker room entrance is loose
 - o Remaining handrail appeared to be secure under a moderate hand force
- Minimal deck crack present in the peninsula

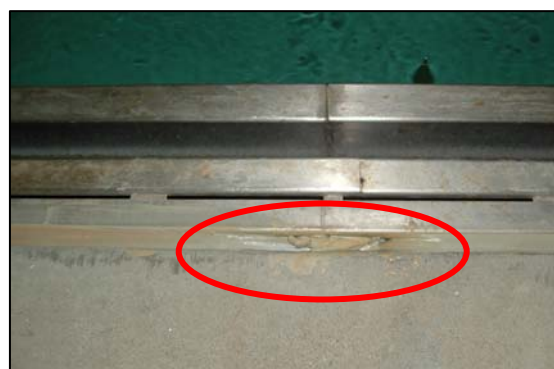
During the initial construction a sealant was placed between the back of the gutter and the concrete deck. This sealant is placed to prevent water on the deck from getting behind the gutter and under deck. At the time of the inspection there were locations where the deck sealant shows signs of deterioration, damage, and even removal. It is important to have these areas repaired. If the conditions remain, water may penetrate the sub-grade materials, over time erosion can occur. Such erosion can create voids under the concrete deck and around the pool shell, reducing the structural integrity of these structures. All the damaged, deteriorating or missing sealant should be removed. The joint should then be properly cleaned and prepared for the application of new sealant.

Fig 6. Gap in sealant

- o Location: across from mechanical room door
- Valve cover not fastened to deck
 - o Location: corner of deck near 5'-0" deep water
- No outlet cover on electrical receptacle

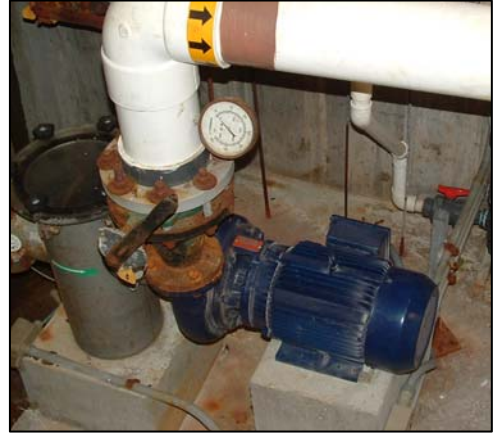
The recirculation pump is the component that is responsible for creating the turnover rate. During the inspection, Larkin observed that the recirculation pump is sized to operate at 402 GPM. This operating condition exceeds the minimum regulations. However, the facility should still verify the pump is operating in this designed range.

Fig 7. Recirculation pump

- o Heater space is naturally ventilated – 24” x 24” louver to outside
- Pump
 - o Nameplate Conditions: 402 gpm @ 65’
 - o Aurora 3x4x9B, Type: 341BE
 - o Motor: 10 HP, 230/460, 3Ø, 1740 RPM, TEFC

1. Confirm turnover rate meets 6 hour time period

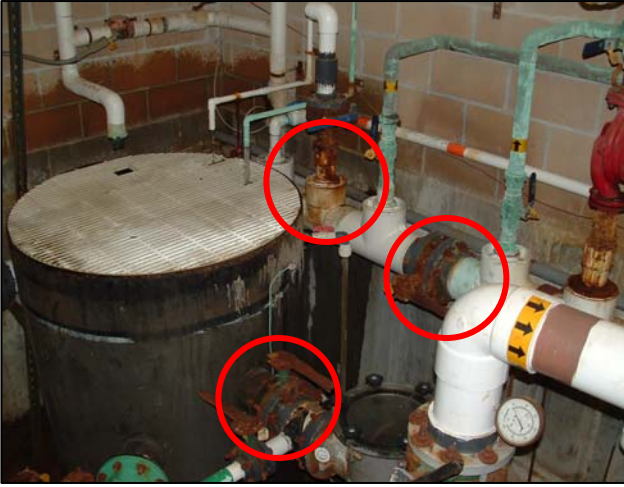
During the site evaluation it was noticed that corrosion has built on components within the mechanical room. The majority of the corrosion has accumulated on pipe fittings. The corrosion has most likely developed from the combination of poor air circulation and the storage of the pool chemicals within the space. To help prevent further deterioration the chemicals should be stored in another location.

Fig 8. Mechanical room

- Corrosion present on the electrical panels
- Corrosion on recirculation valves and valve handles
- Chemical stored were being stored in the equipment space – 2 buckets

1. Remove pool chemicals from equipment area
2. Monitor corrosion, replace equipment as needed

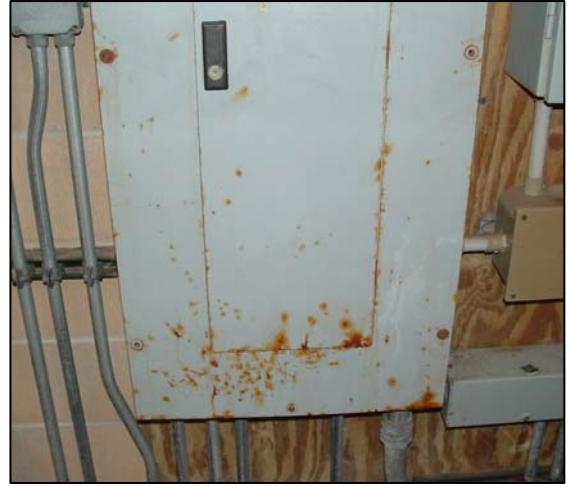
In addition to the concern of the piping and equipment corrosion, the area's electrical panels showed signs of corrosion. Facility staff should monitor the condition so that the situation does not worsen, causing operational malfunctions and compromise the safety of staff.

Fig 9. Electrical panel

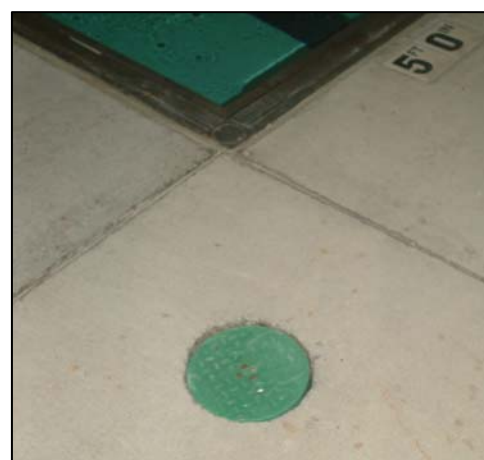
There is a valve located within the deck, adjacent to the mechanical room entrance. The valve has a high-density plastic cover. At the time of the inspection the cover was not secured in place. The staff should secure this valve cover to prevent a tripping hazard, and prevent potential tampering.

Fig 10. Valve cover

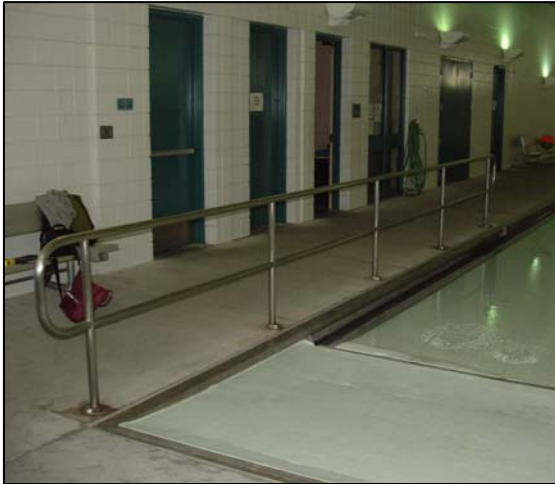
There are stainless steel handrails on the deck that run parallel to the sloped entry area. The handrails appear to be in acceptable condition. However, the rail across from the natatorium entrance, and pool office, wobbles under a moderate hand force. The staff should securely fasten the handrail for patron safety.

Fig 11. Loose handrail

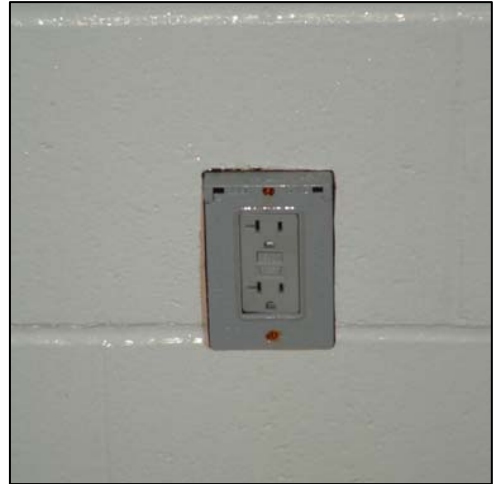
Fig 12. Receptacle cover

The perimeter wall of the natatorium has numerous electrical receptacles. A few of the receptacle have loosened or missing cover plates. The staff should repair or replace these covers to prevent potential hazards.

- o Location: wall near 5'-0" deep water
